TECHNICAL REPORT GL-85-11

DUSTPROOFING UNSURFACED AREAS; FACILITIES TECHNOLOGY APPLICATION TEST DEMONSTRATIONS, FY 84

Clarence R. Styron III, Robert A. Hass, Karen Kelley

September 1985

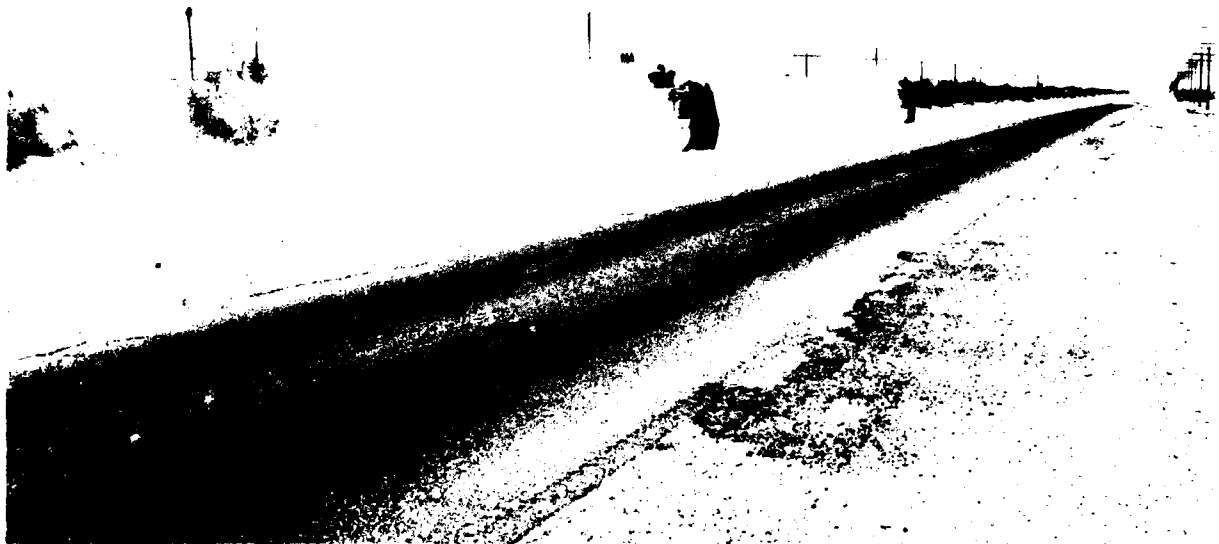
8. Fort Stewart, Ga., and Fort Bliss, Tex., were selected for the fiscal year 1984 demonstration sites. Both locations had an immediate need for dust control. Wheeled and tracked vehicles were producing dust on the silty sand roads, and this dust was blowing into the family housing area (Fort Stewart) and nearby adjacent commercial enterprises (Fort Bliss, Figure 1).

Figure 1. Dust at Fort Bliss, Tex., prior to treatment

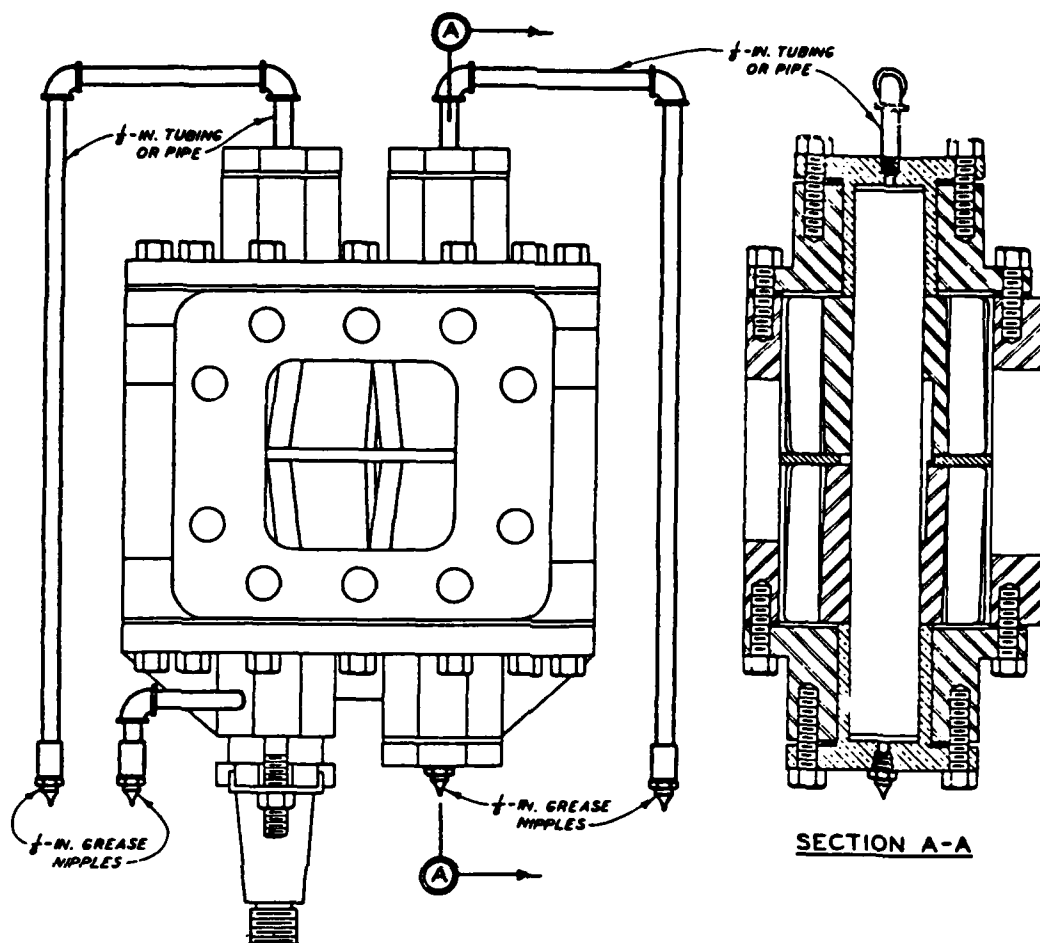
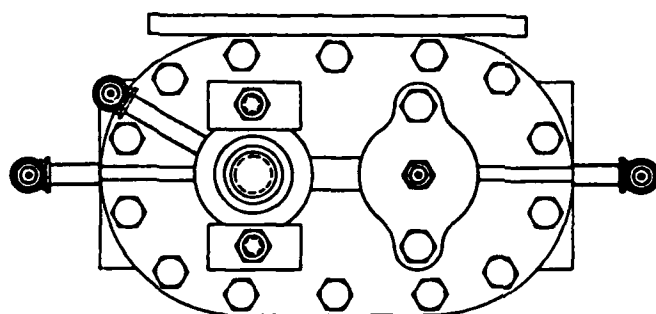
LEGEND
 == GREASE FITTINGS AND LINES
 INSTALLED TO LUBRICATE
 PUMP SHAFT BUSHINGS

Figure 2. Typical pump modification requirements for conventional asphalt distributor

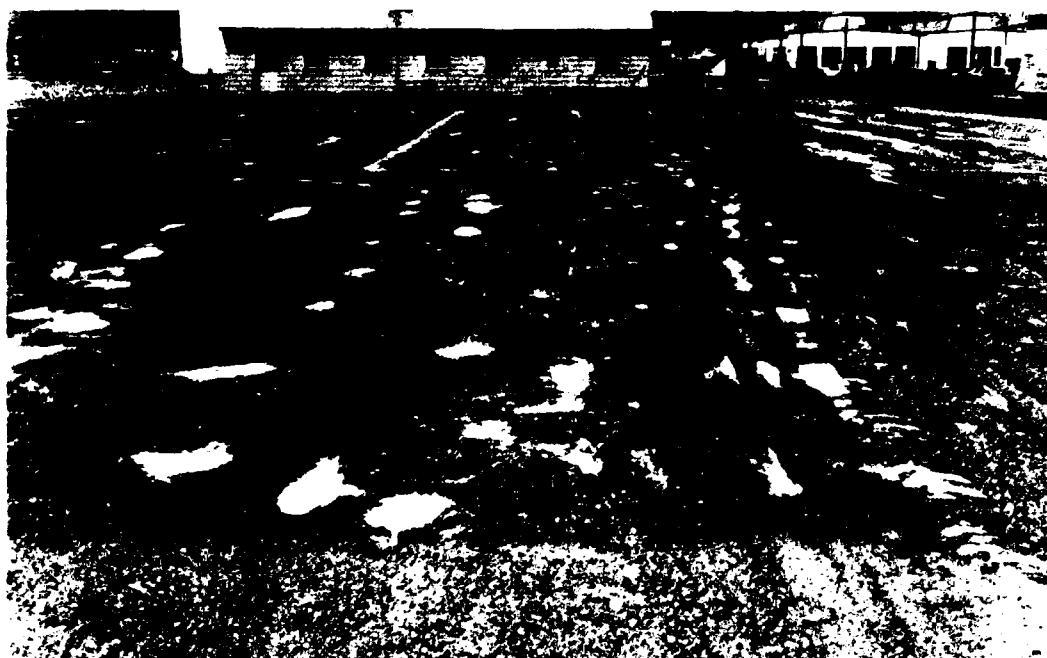
28. Small depressions and ruts (the treated surface caused by the distributor tires) were filled with PVA, and these ponded areas cured much more slowly than the nonrutted areas (Figure 7). The ponded material cures from

Figure 7. The PVA treated surface, Fort Bliss, Tex.

the surface down; if left undisturbed, it may take months to cure completely. This does not impair the dust control integrity of the treated area in any way.
